# Property Inspection Report

PROPERTY TYPE	COMMERCIAL	DATE OF LOSS	
POLICY #		DATE OF CONTACT	2/27/2019
CLAIM #		INSPECTION DATE	3/2/2019
JOB #	13626	REPORT DATE	3/2/2019

JOB #:13626  
1300 E BROADWAY ST  
PEARLAND, TX 77581

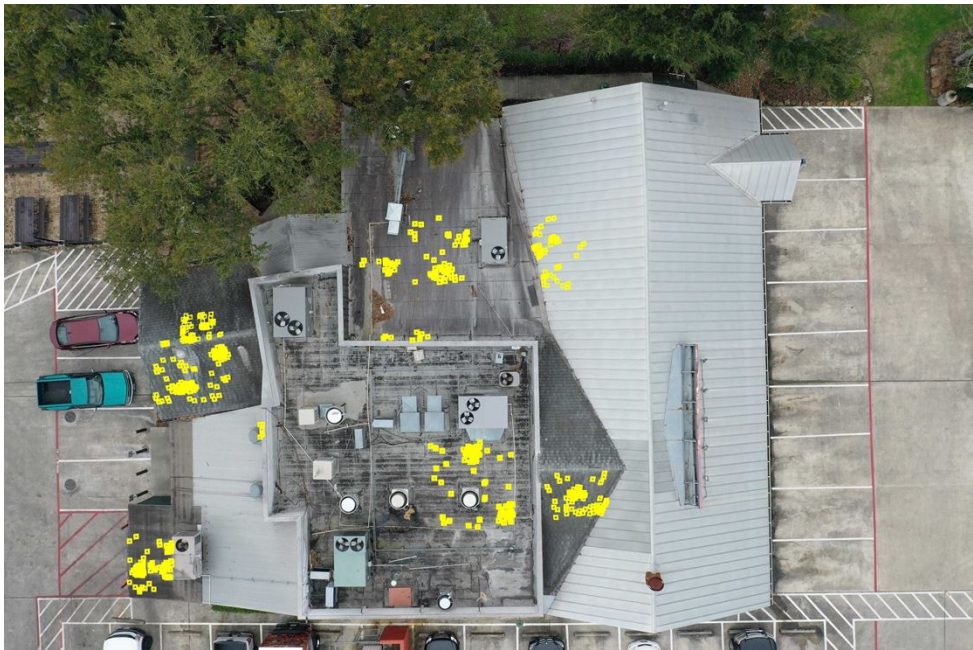
Overview of the rooftop

Hail damages are detected, as indicated below in detail.

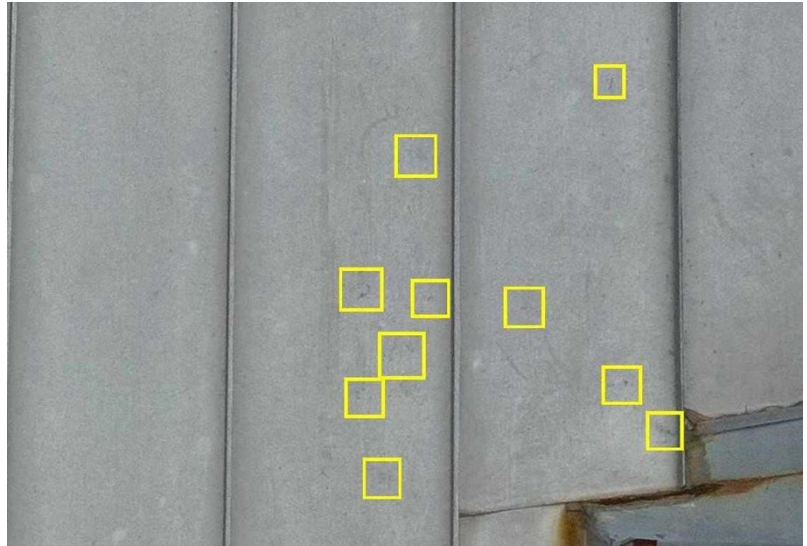
## 3. Closeup of the front slope

Further detail of last image

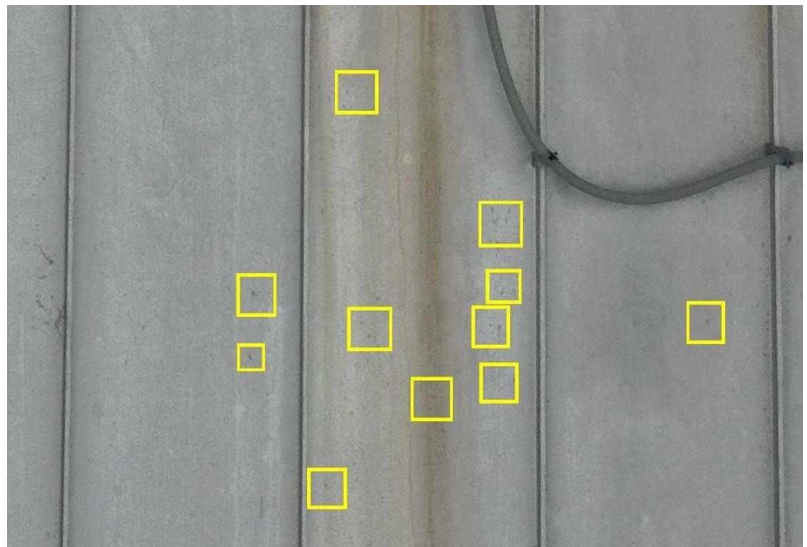
## 4. Closeup of the front slope

Further detail of image 2

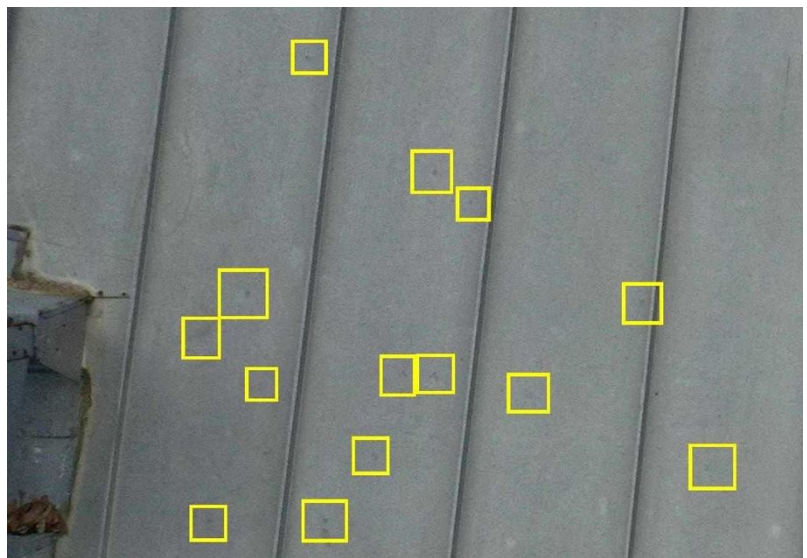
## 6. Closeup of the front slope

Further detail of last image

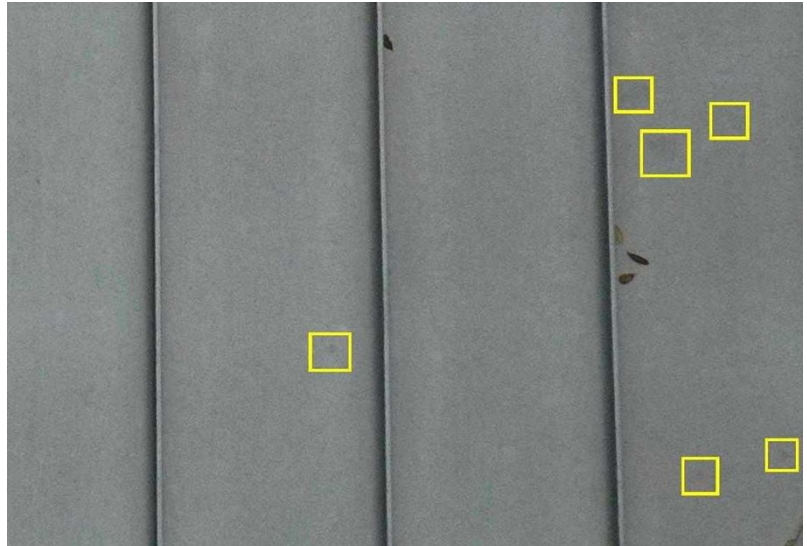
## 7. Closeup of the front slope

Further detail of image 5

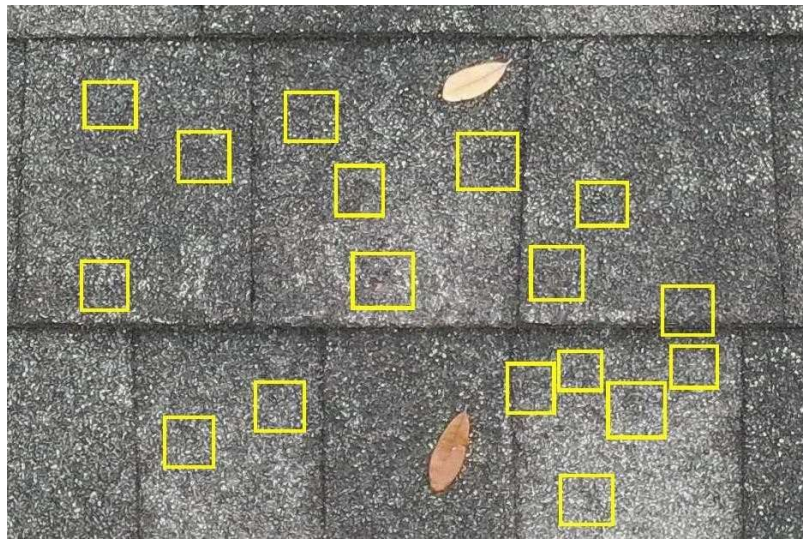
## 10. Closeup of the right slope

Further detail of last image

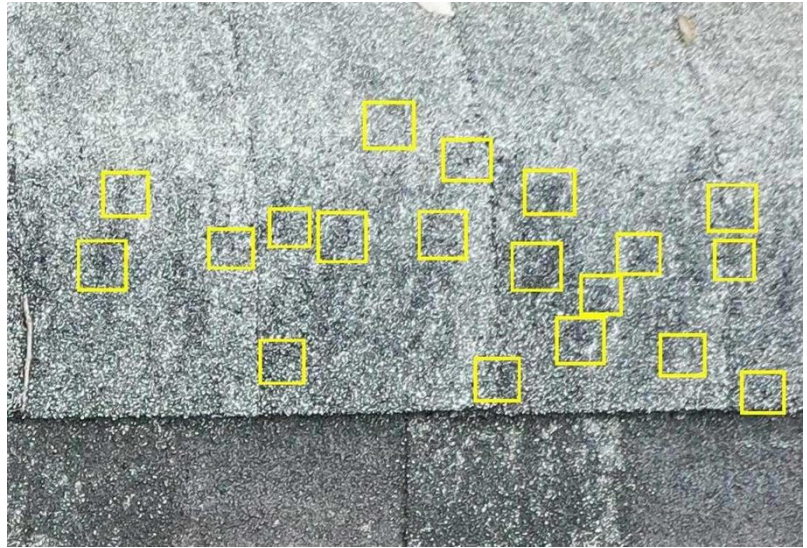
## 11. Closeup of the right slope

Further detail of image 9

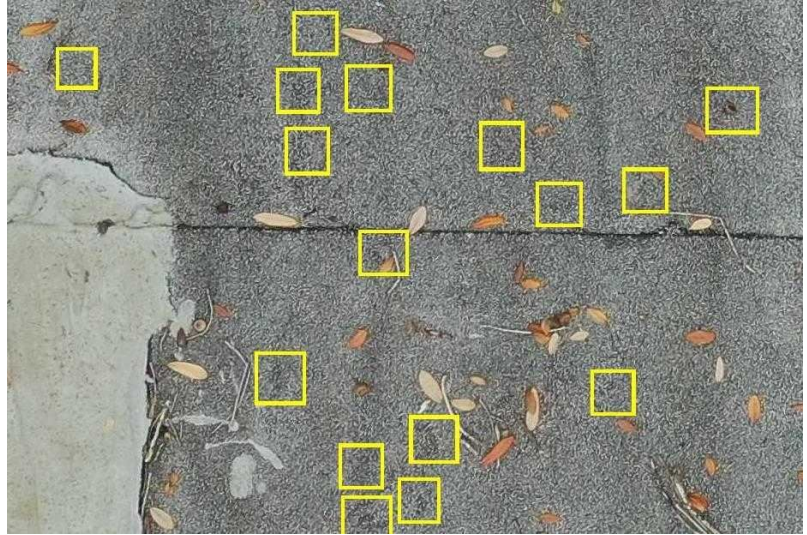
## 13. Closeup of the right slope

Further detail of last image

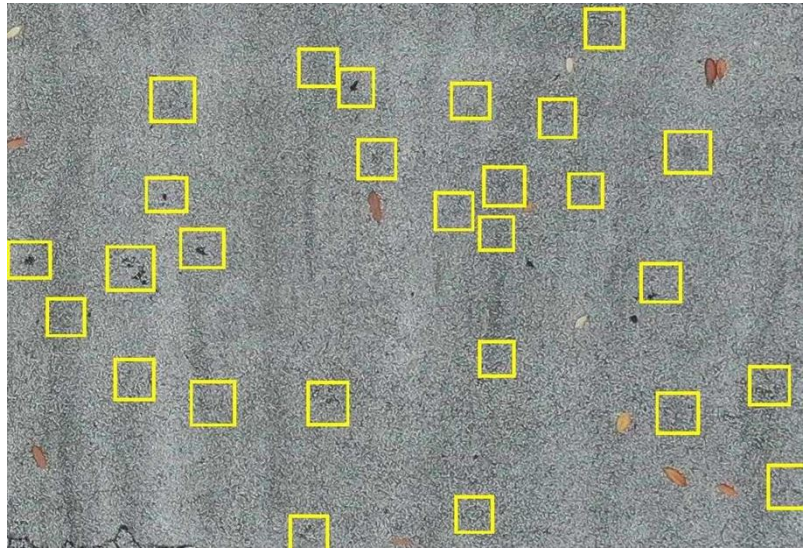
## 14. Closeup of the right slope

Further detail of image 12

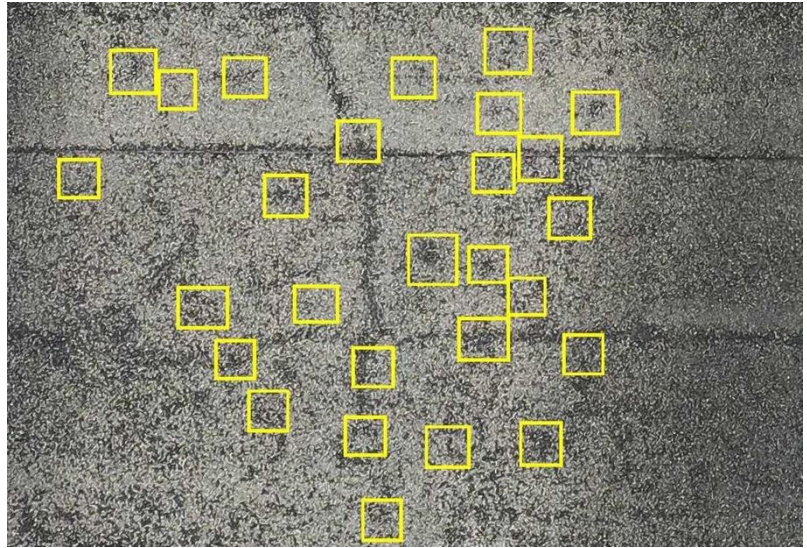
## 17. Closeup of the rear slope

Further detail of last image

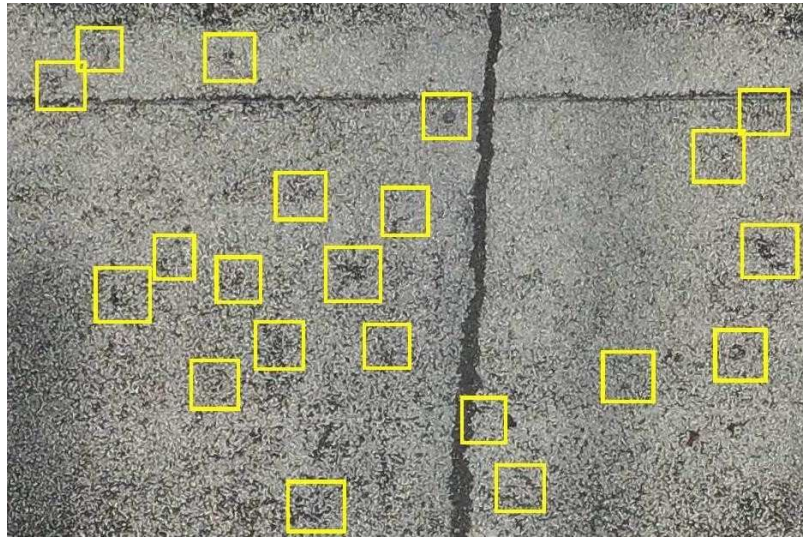
## 18. Closeup of the rear slope

Further detail of image 16

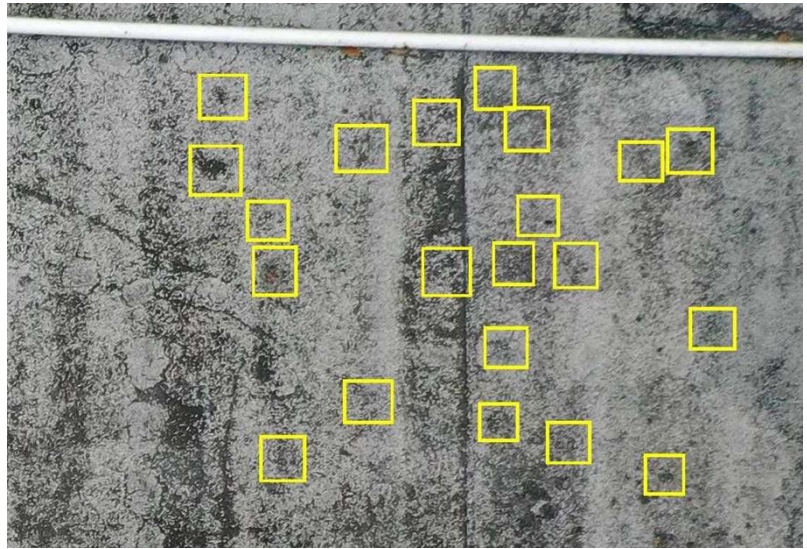
## 20. Closeup of the rear slope

Further detail of last image

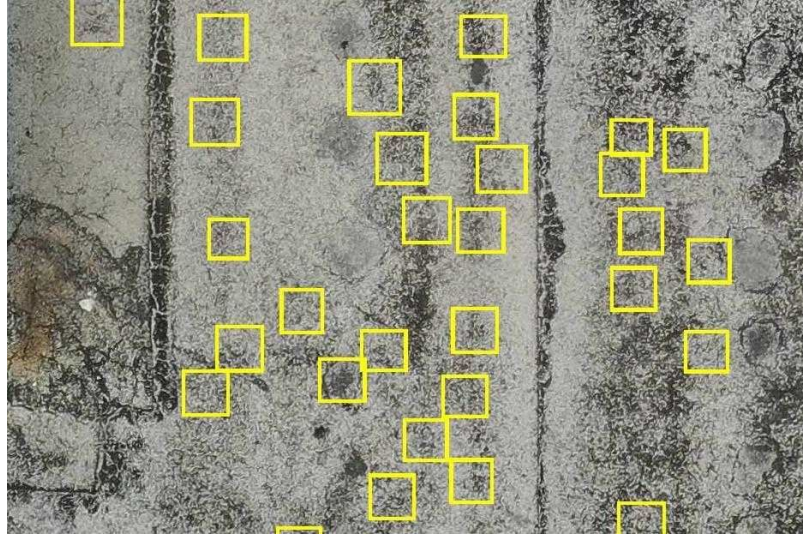
## 21. Closeup of the rear slope

Further detail of image 19

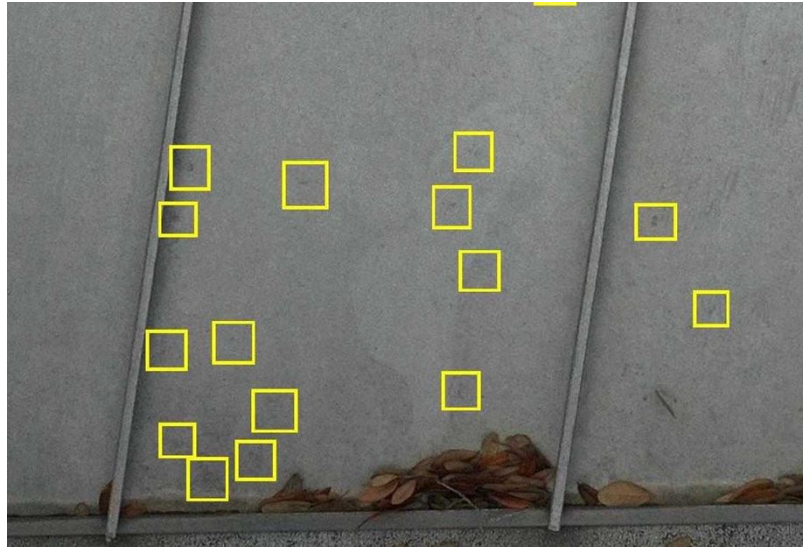
## 23. Closeup of the rear slope

Further detail of last image

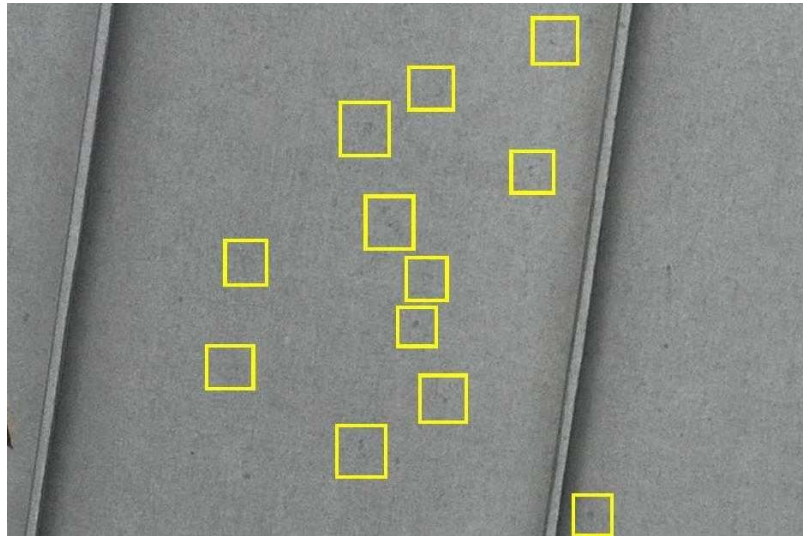
## 24. Closeup of the rear slope

Further detail of image 22

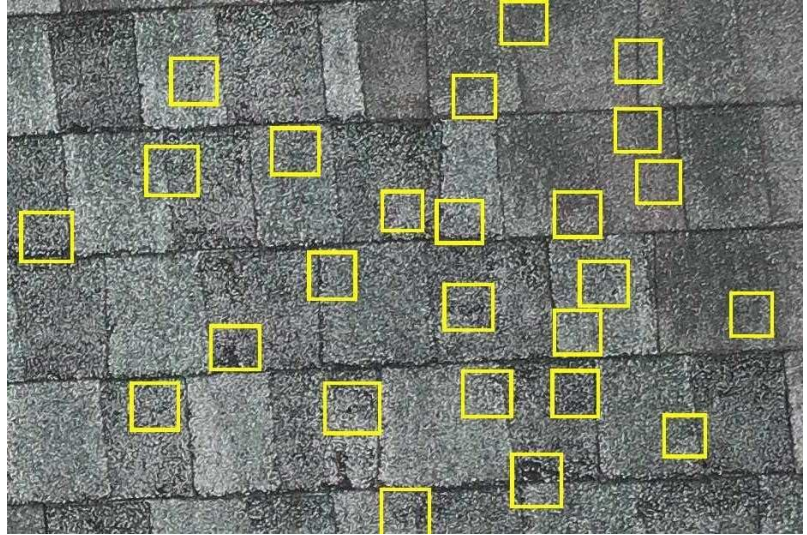
## 27. Closeup of the left slope

Further detail of last image

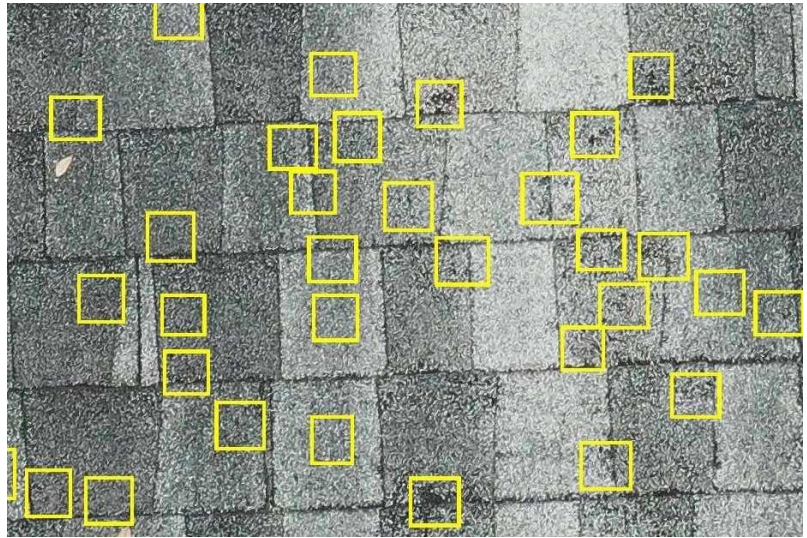
## 28. Closeup of the left slope

Further detail of image 26

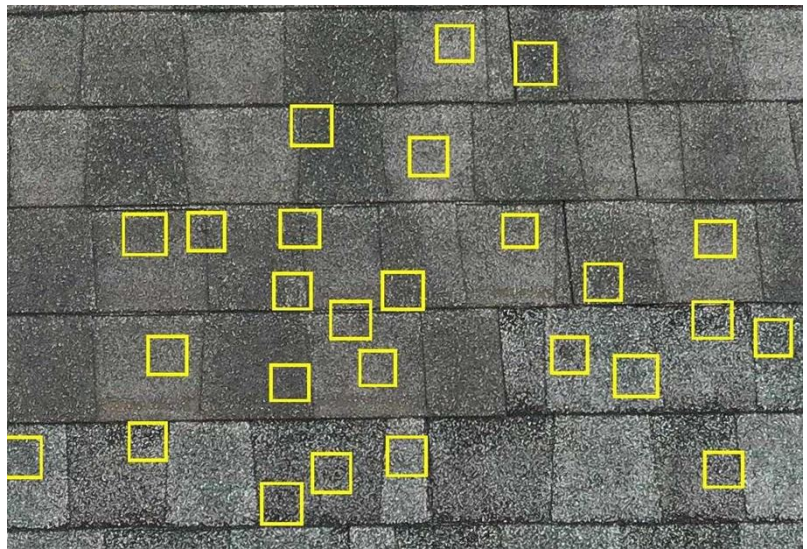
## 30. Closeup of the left slope

Further detail of last image

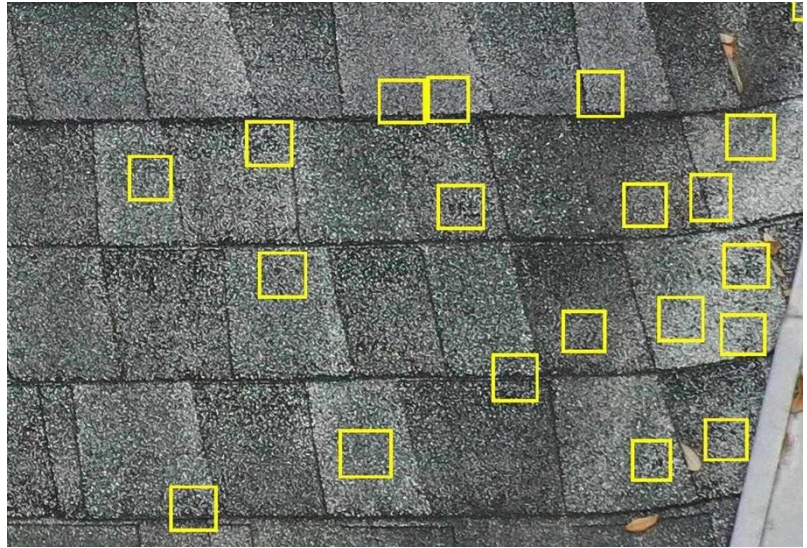
## 31. Closeup of the left slope

Further detail of image 29
